# GEOLOGY OF SANTA CECILIA TUNNEL

PORTLAND P. FOX  
Light and Power Company

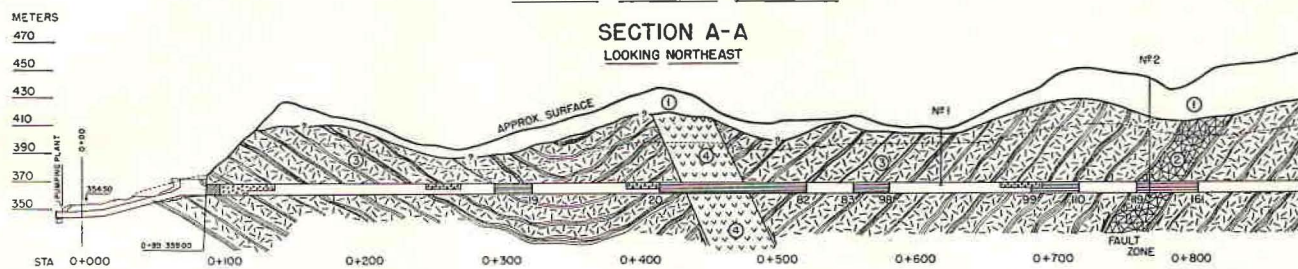
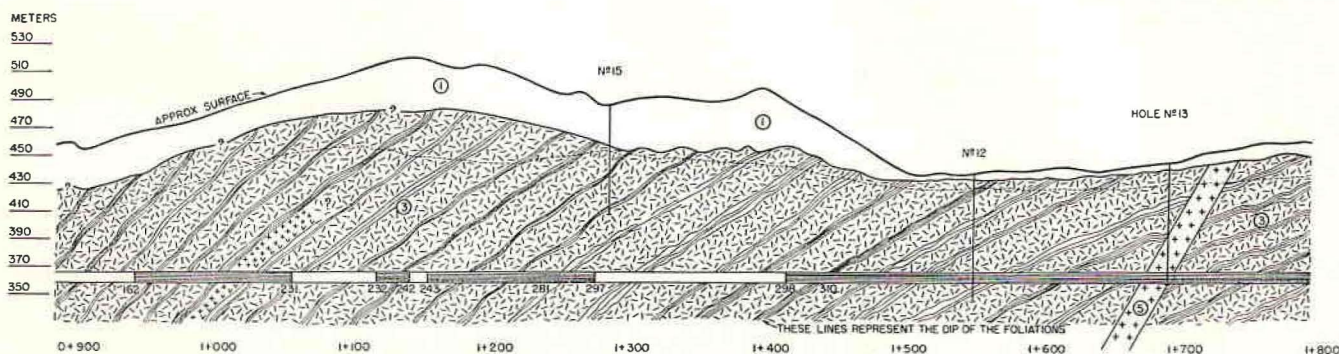
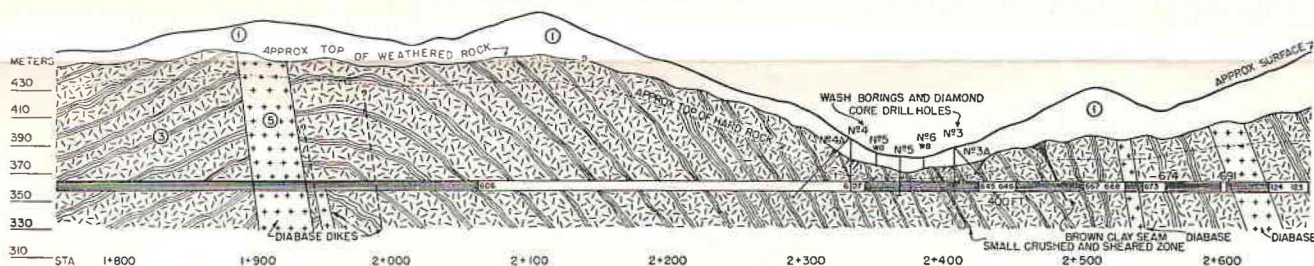
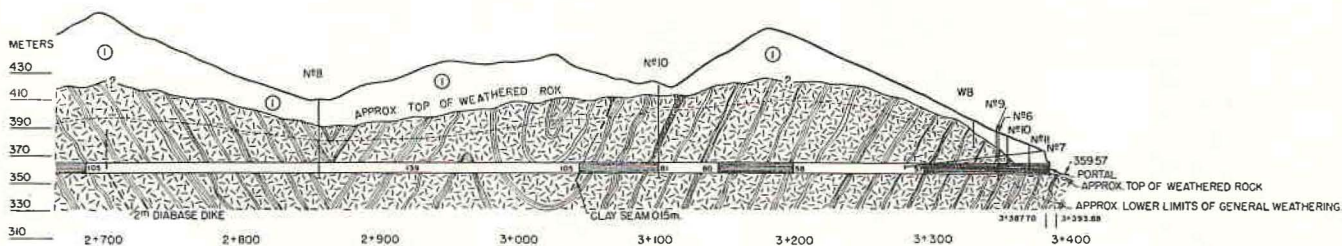
Fig. 2

A rather accurate preliminary geologic section was prepared from the information obtained from the borings and surface indications. The attached geologic section, Figure A, contains more details than the original sections but it required little modification in the structure of the gneiss.

A large fault zone at station 7 + 80 caused considerable delay and extra expense. By chance, core drill hole No. 2 penetrated this fault zone and its existence was known prior to encountering it. However, the hanging wall portion did not appear to offer any tunneling hazards, but serious difficulty was met with when a meter of soft, clay-like gouge along the foot wall was penetrated. During a period when no one was working in the tunnel, the back of the tunnel caved in because of improper supports. A large hole was formed in the roof which required extensive supports and considerable delay. This zone was grouted after the lining was placed with a slurry of neat cement, to fill up the voids above the tunnel lining. A total of 65,409 bags of cement was used in grouting all of the tunnel.

Closely spaced, steel supports were required only at relatively few zones such as the fault zone at 0 + 780 and the altered zones of rock at 1 + 020 and 0 + 450.
